Goose Creek Demonstration Subwatershed Plans

Assessment and Recommendations for Three Subwatersheds within
the Goose Creek in Northern Virginia

July 2003

for Piedmont Environmental Council
and Goose Creek Association
July 2003

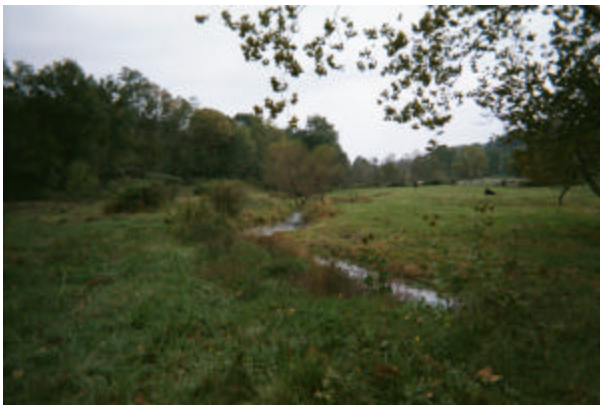
Figure 8. Stream reach in need of streamside reforestation

HW 105-1: Streamside Forestation

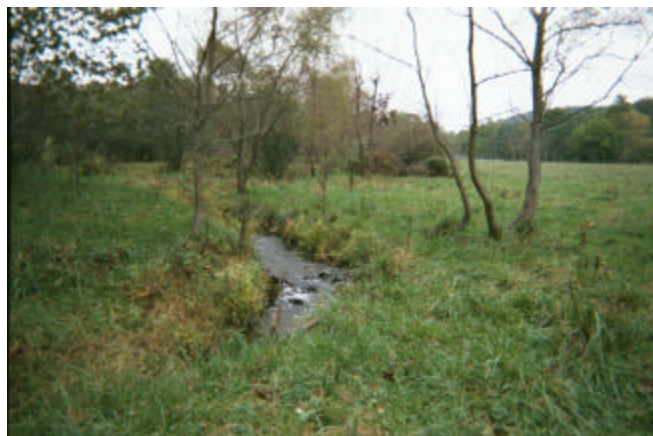
This parcel has a total of 435 feet of inadequate buffer and cattle access between the two stream branches that lie on the property. Restoration activities at this site should include buffer forestation, accompanied by livestock management for the cattle. This management should include fencing, an off-stream water source, and improved crossings. The prominent location along the Rt. 688 would make it a good demonstration project site.

Figure 10. Inadequate buffer at site HW 105-3

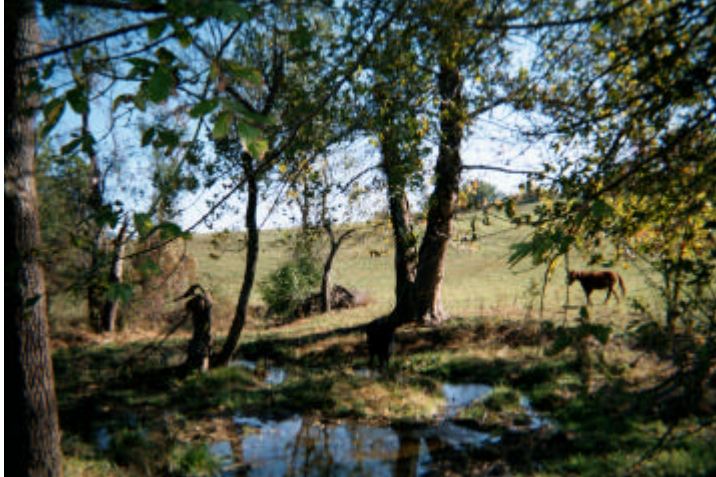
One agricultural restoration opportunity was identified during the stream assessment in this catchment. This stretch of stream runs parallel to Rt. 688 and has several low-grade impacts including cattle access, inadequate buffer and stream bank erosion.

Figure 11. Inadequate buffer, livestock access and water quality impacts at site HW 105-4

HW 105-4: Livestock Management System and Streamside Forestation

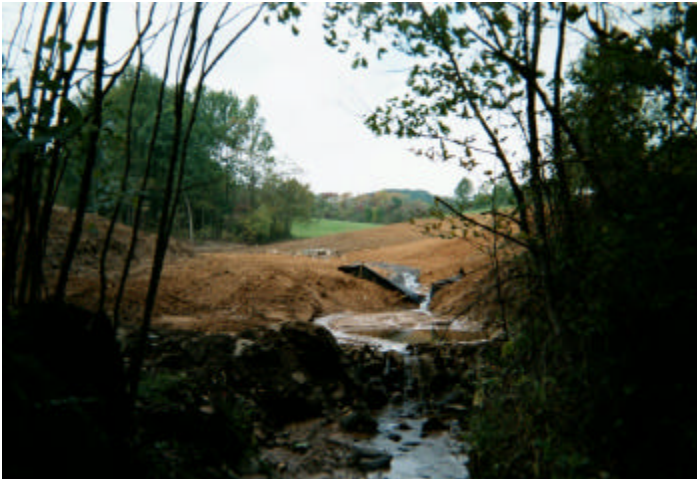
Figure 12. Failing ESC practices at a construction site in Catchment 104

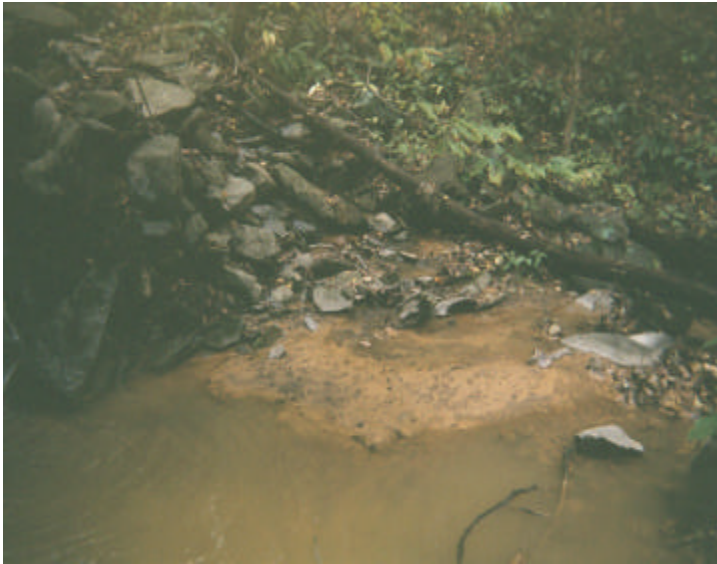
Figure 13. Heavy erosion and sedimentation in stream near construction site

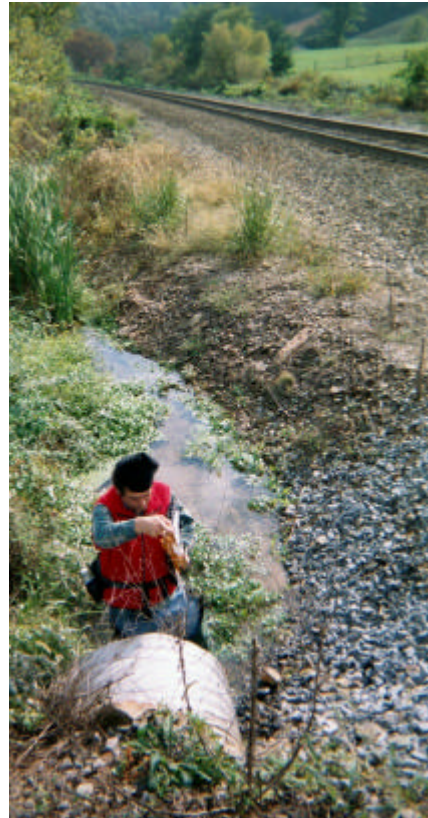
This reach is similar to the site at HW 105-6. While the impacts are severe, the proximity of the railroad makes complete restoration unlikely. Again, an investigation of this site is needed but the restoration potential here is uncertain.

Figure 14. Inadequate buffer near railroad tracks

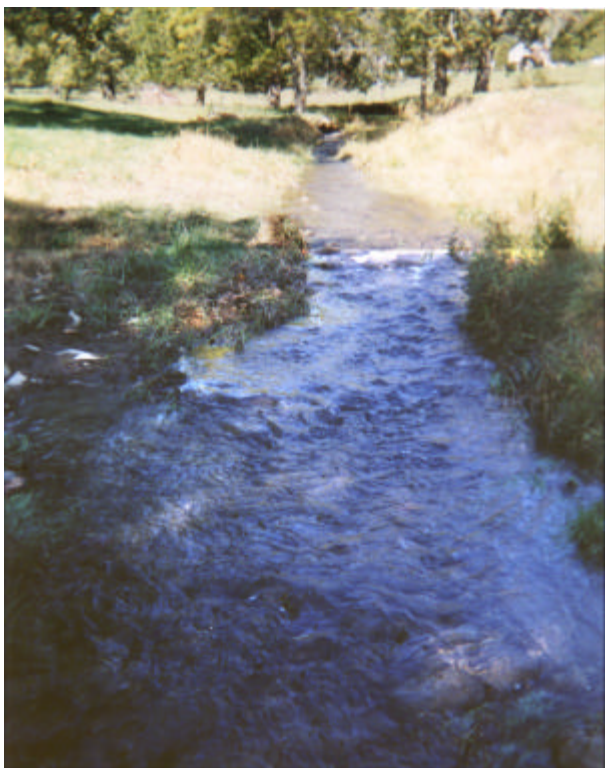
Figure 15. Bank stabilization, streamside plantings and buffer forestation needed here

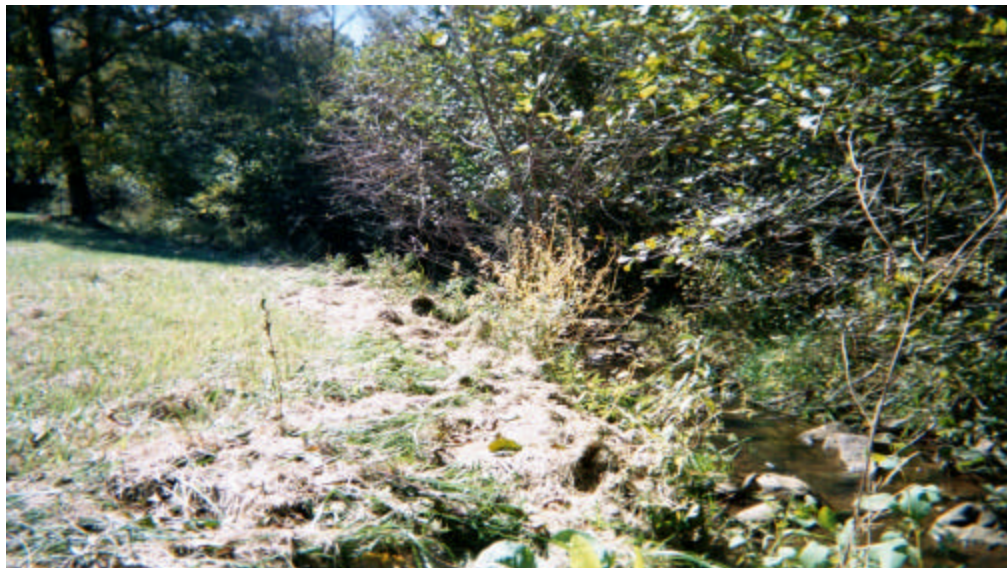
Figure 17. Inadequate buffer was common in North Fork 102

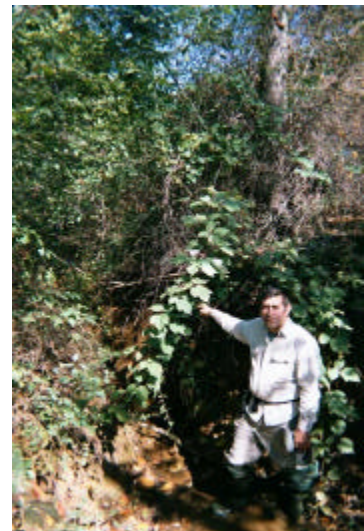
Figure 19. Candidate for stream restoration; site NF 102-1

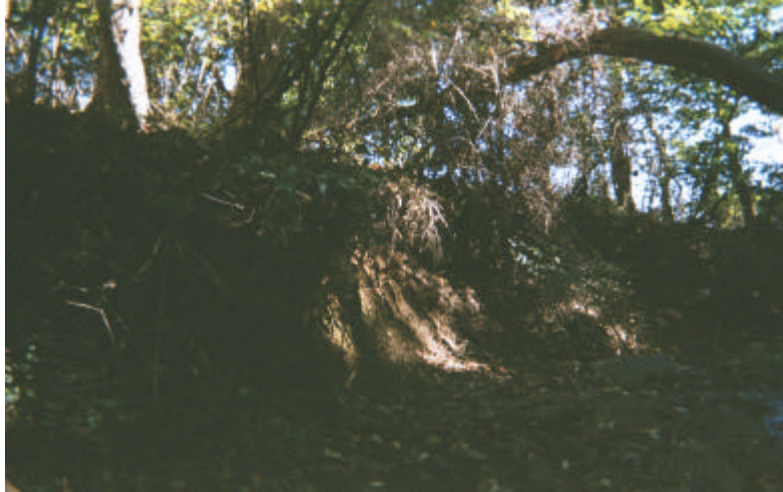
This location has 226 feet of severe streambank erosion (see Figure 20). Streambank stabilization is recommended to reduce the sediment export from this site. The extremely high banks make this a somewhat challenging project, and the first phase of any streambank restoration would be to flatten the angle of the banks. This project would require further investigation to implement.

Figure 20. Severe channel erosion at site 102-2

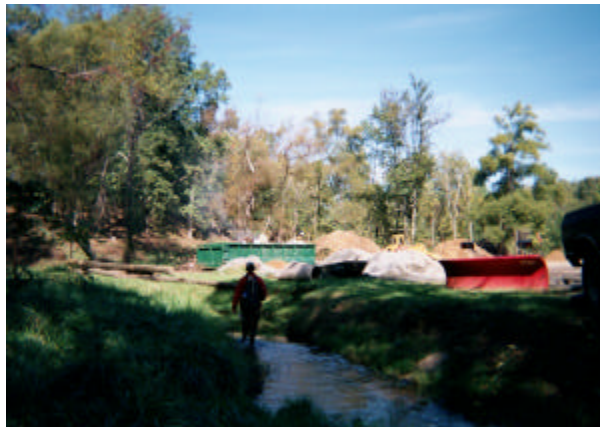
Figure 22. Buffer encroachment at site NF 102-6.

NF 102-6: Stream Stabilization/ Streamside Forestation

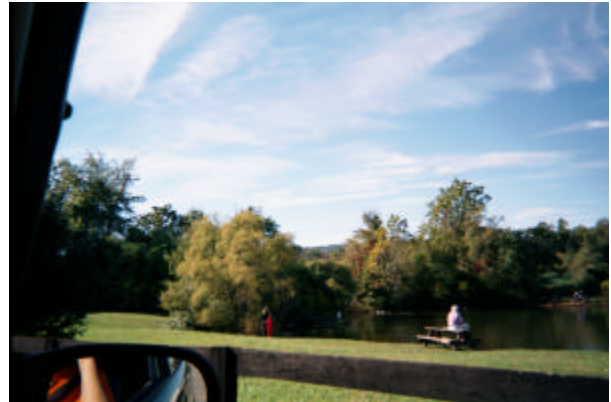
Figure 23. Possible buffer planting area at site 102-7

NF 102-7 Plantings at In-Stream Ponds
Buffer plantings at the shore of the three stormwater ponds adjacent to Route 7 (see Figure 23) can act as a demonstration project due to their visibility. This project could be accomplished in conjunction with education and outreach directed specifically at these landowners. Further investigations may lead to the possibility of more aggressive modifications to the practice, including features such as aquatic benches and wetland features.

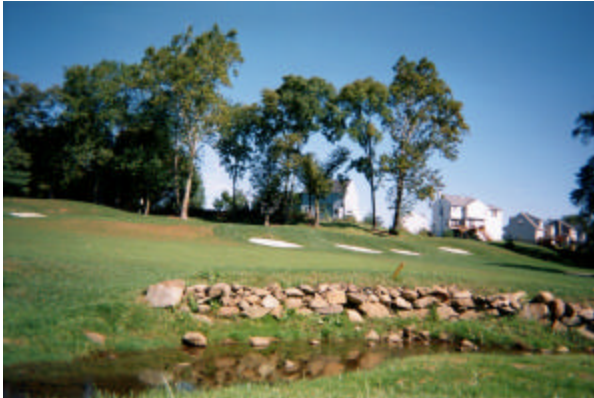
Figure 24. Inadequate buffer adjacent to Stoneleigh Golf Course

NF 102-8 Streamside Forestation Through Route 7 and Adjacent to Stoneleigh Golf Course (see Figure 24)

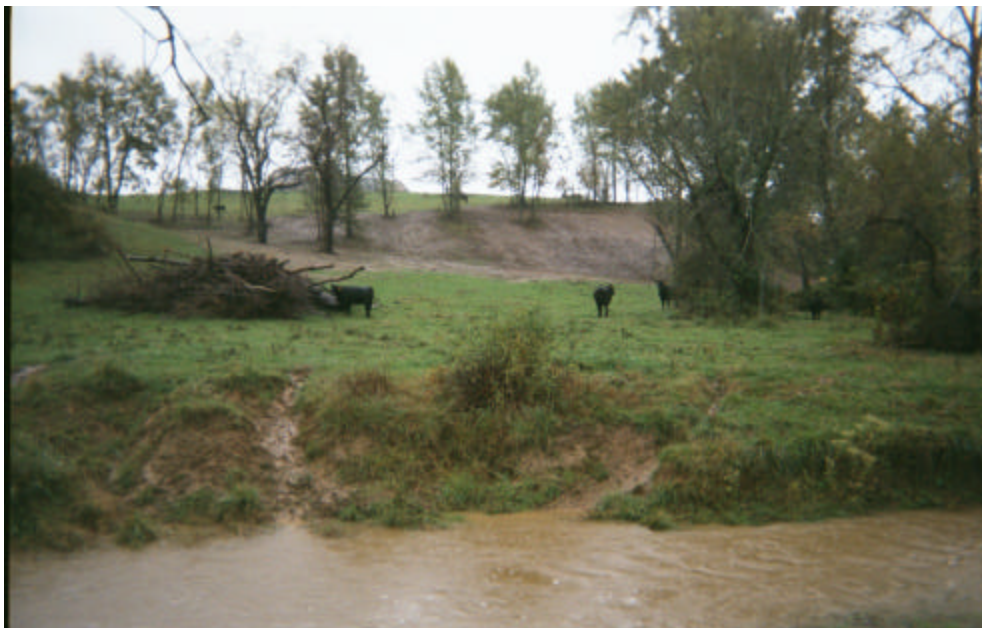
Figure 26. Stream with cattle access - a major problem within North Fork Upper Direct Drainage

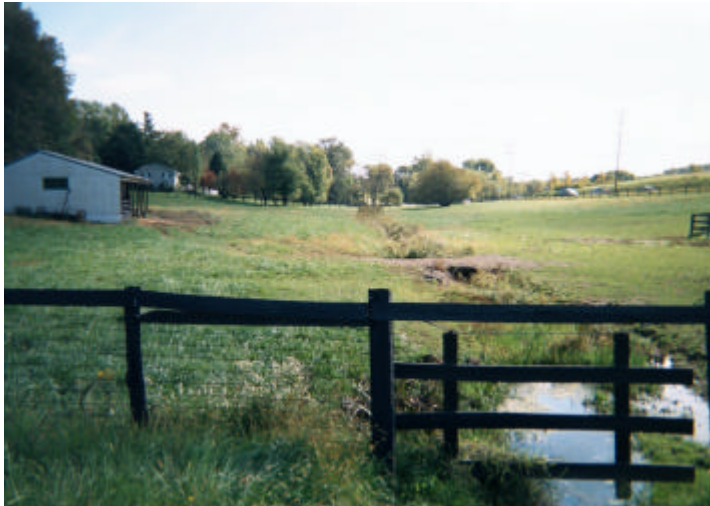
Figure 27. This stream section clearly shows inadequate buffer and livestock access.

NFUpDD-1: Streamside Forestation/ Horse and Burro Access

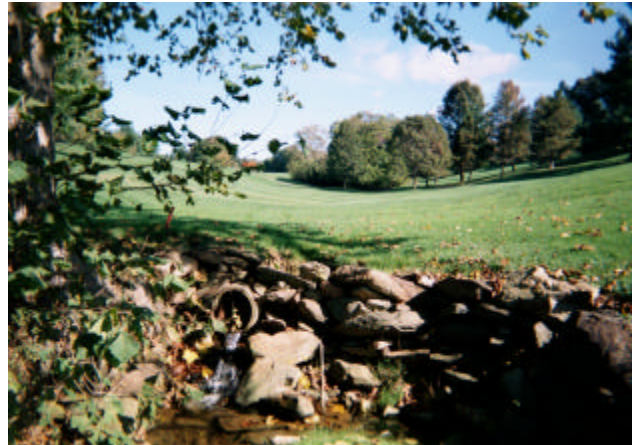
This location in the golf course (see Figure 28) is currently in a culvert. Stream daylighting can help bring this stream back to life and become an educational opportunity. This project is not a very high priority, however, due to the minimal benefit to the subwatershed as a whole.

Figure 28. Stream section in need of daylighting

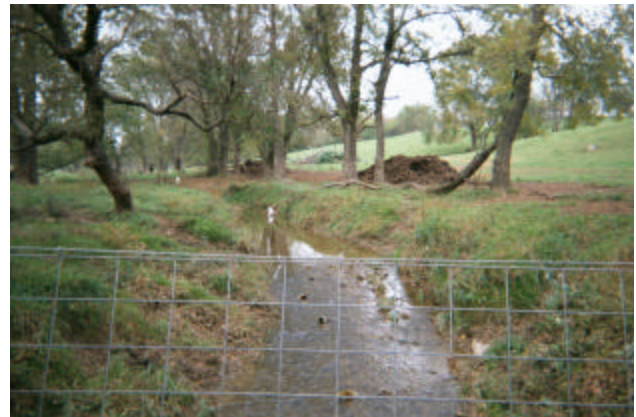
The Purcellville WWTP sludge field is a potential point source for pollution. Sampling and monitoring samples can help determine pollutant levels and identify ways to arrest potential, future impacts on the stream. Outreach should also focus on potential stream restoration near this site (See NF UpDD-5).

Figure 29. A manure storage pile adjacent to stream in catchment 102.

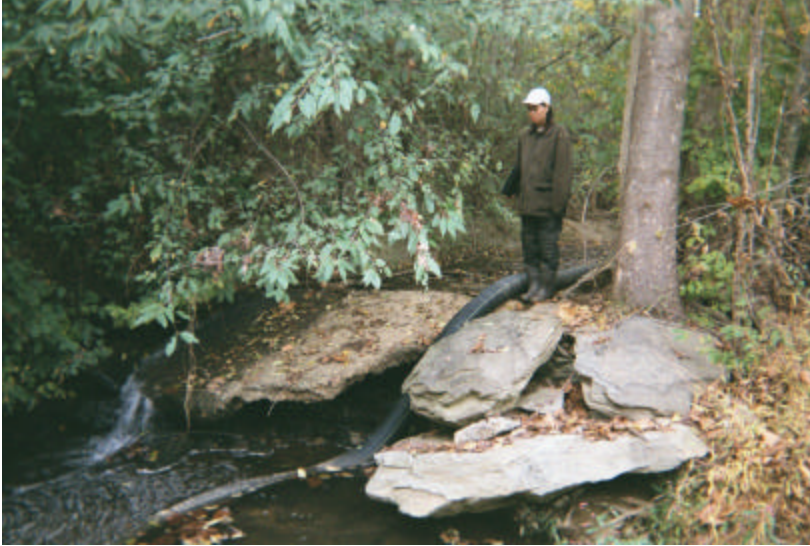
Figure 30. Outfall pipe from a sludge field

investigate the feasibility of installing a stormwater wetland to capture untreated stormwater. The proposed retrofit could treat runoff from several stormwater outfalls (see Figure 30) and an existing stormwater detention facility. Cleaning up streamside areas can also help prevent debris from entering the stream.

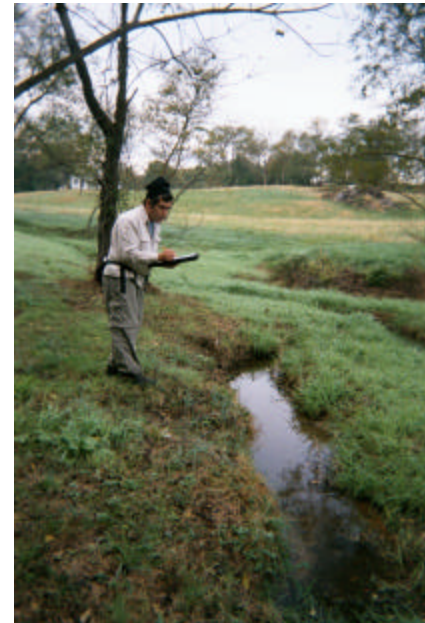
The inadequate buffer, cattle access, and overall moderate watershed erosion make this area a good candidate for restoration (see Figure 31). Specifically, we recommend a livestock management system, combined with streamside forestation. While some erosion exists here, we recommend a passive approach, allowing the stream to repair itself once livestock access is limited, and riparian cover is established.

Figure 31. Livestock management and streamside forestation repair needed in this moderately impacted stream

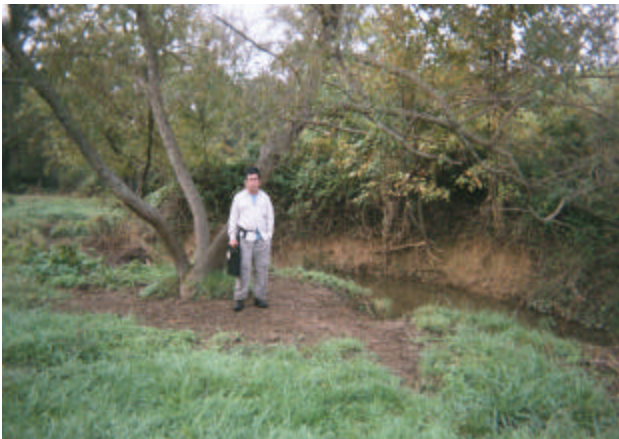
Figure 32. Potential restoration site with impacts from cattle access, an inadequate buffer and erosion.

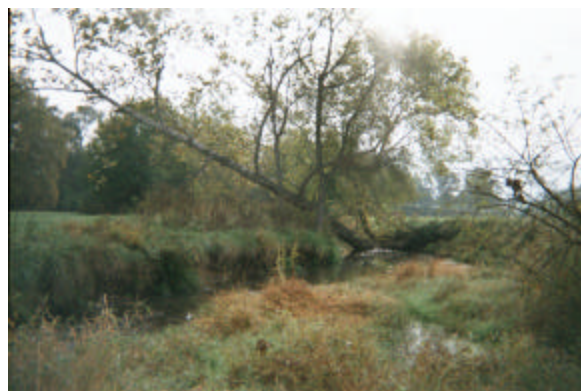
Figure 33. Stream with water quality impacts due to inadequate buffer and horse access

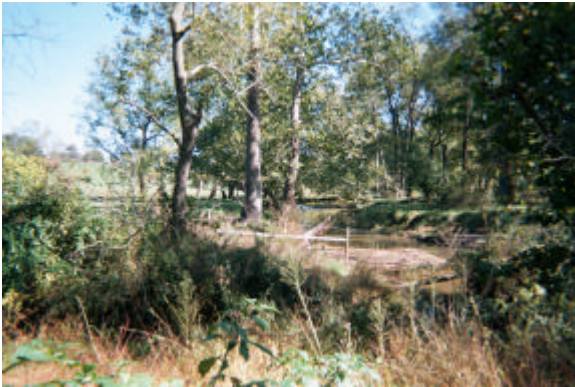
Inadequate buffer and cattle access caused moderate water quality impacts to this stretch of stream. A combination of livestock management for cattle and streamside forestation will repair this stretch of stream.

Figure 34. Another site with inadequate buffer, cattle access and water quality impacts
